Restoration of a Wisconsin Model TFD Engine
by
David Kirk

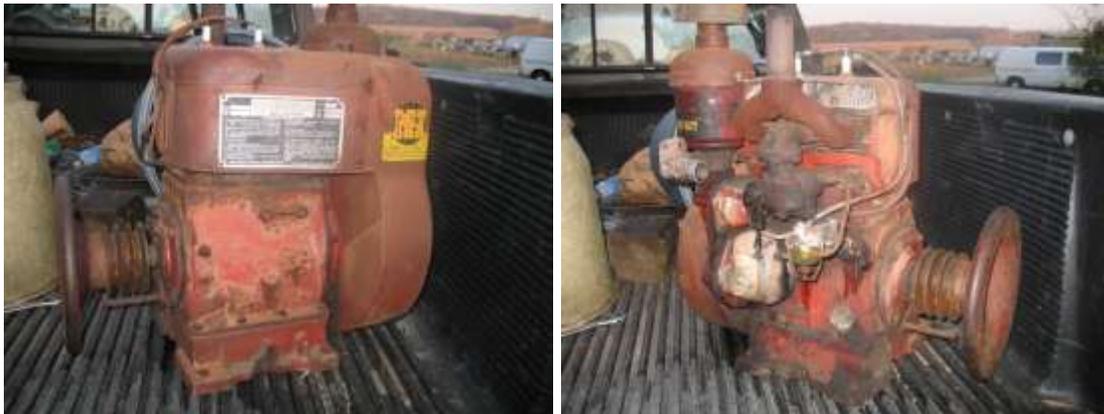
My engine was obtained through Joe McCarthy, a good friend and colleague, who purchased it at an auction for me. As received it was in well-used condition, originally being a power source for a New Holland hay bailer.

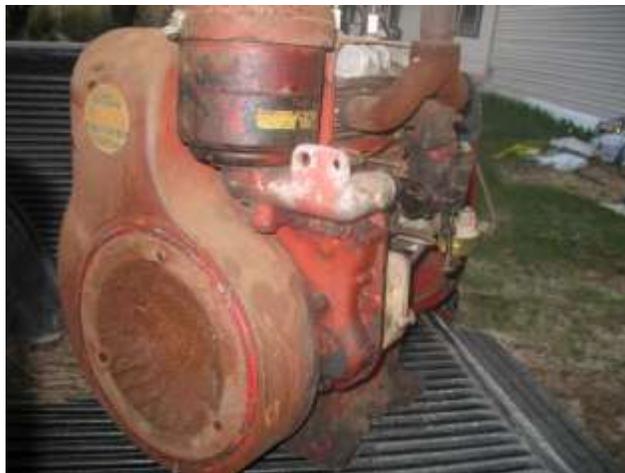
All of the parts seemed to be in place and the crankcase was filled to the proper level with oil. Compression was a bit weak though, and favored one cylinder over the other. The Wico magneto provided a healthy spark, thus a test run was in order.

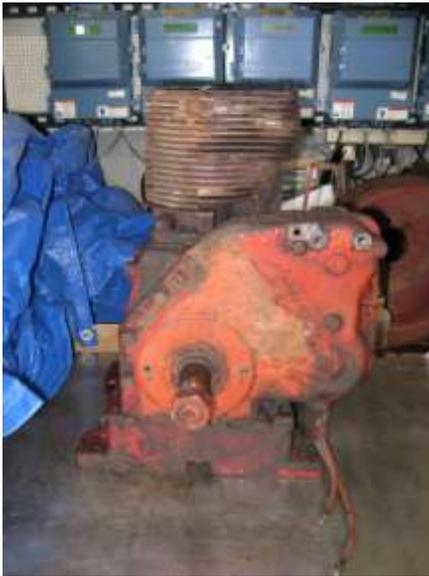
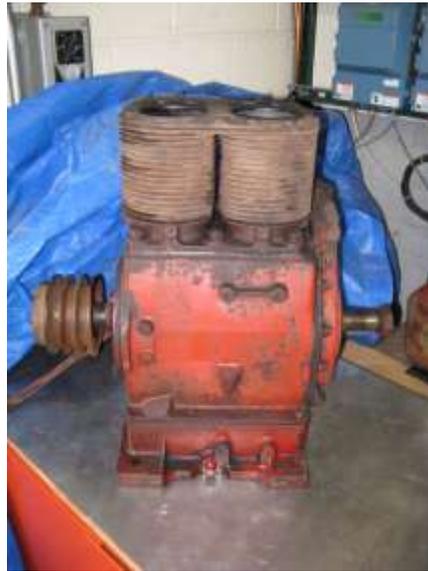
Removing the sheet metal shrouding from the cylinders indicated that I was probably the first to perform this operation since the engine left the factory! All cooling fins around the cylinders, and those fins on the head, were virtually blocked solid with dirt and chaff. It was amazing that it could still operate.

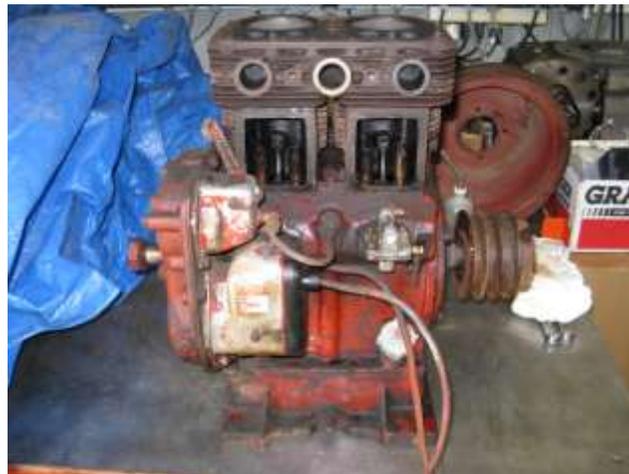
Removing the valve spring covers proved that this engine had been running hot – black, carbonized oil was present.

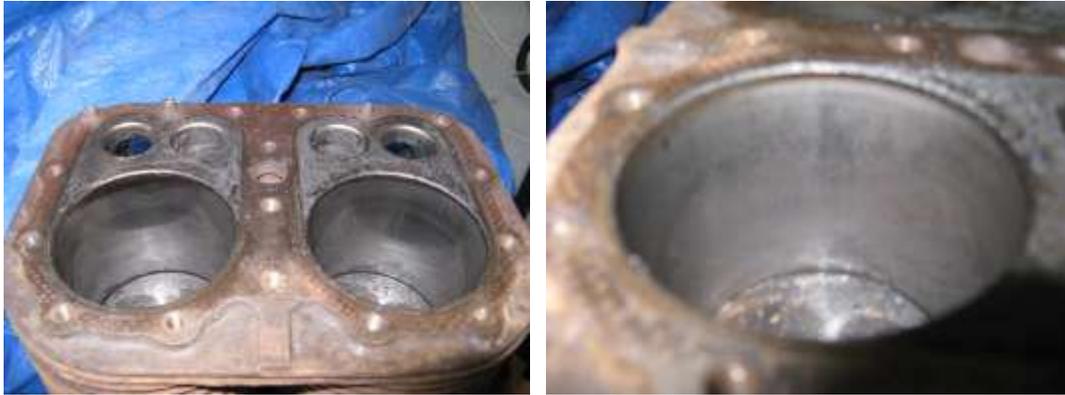
Pistons were so loose in their bores that they would rock from side-to-side as the engine was rotated over TDC. The cylinder walls were glazed to a dull mirror finish. The intake valves were so worn on their seating surface that they weren't worth regrinding. The exhaust valves however, were in perfect shape!

With the poor condition of these top-end parts, it was obvious that a rebore with new pistons, rings, and intake valves had to be done to put this great old engine back to first-class shape.

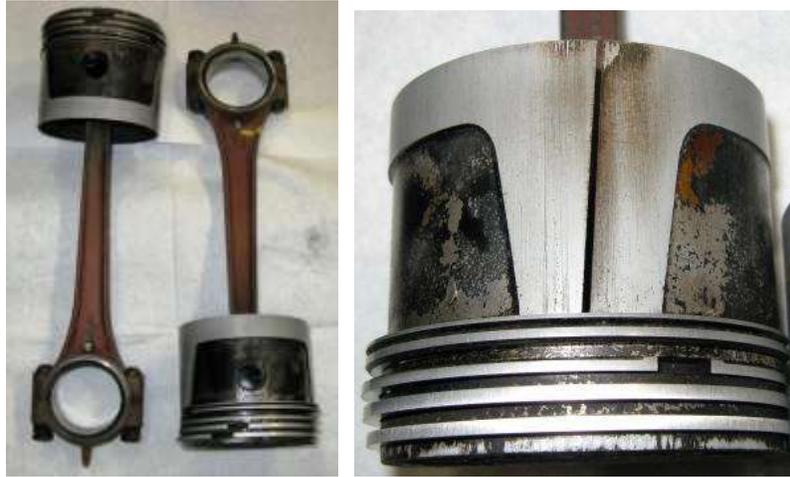
Next, the pistons and rods were removed for inspection. The long, forged steel rods with babbitt main bearings have a touch of antiquity about them. The aluminum pistons are fitted with three compression and one oil control ring. The pistons also have slotted skirts to minimize slap, but this feature had long since

given up its function due to heavy skirt wear, most likely caused by running too hot. I was amazed that none of the rings were stuck in their grooves.

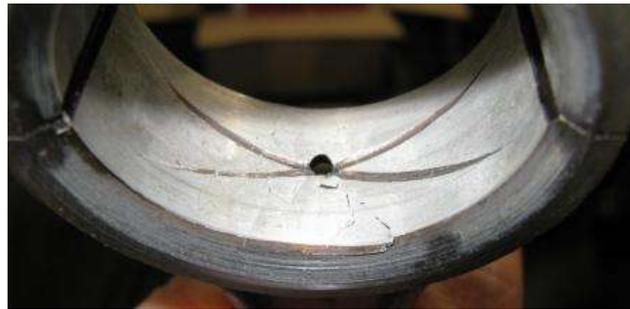
Inspecting the con rod crankpin bearings showed some cracking in the babbitt material, probably caused by the engine running in continuous detonation due to lack of proper cooling.

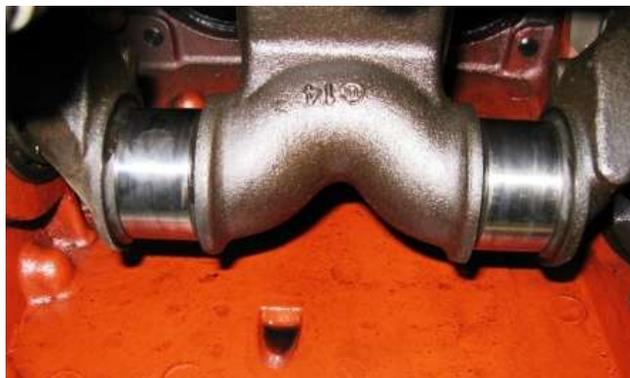
Measuring up the crankpin journals revealed that virtually no wear was present...they were perfectly cylindrical with a bright and uniform surface finish. Finally – a part that won't need reconditioning!

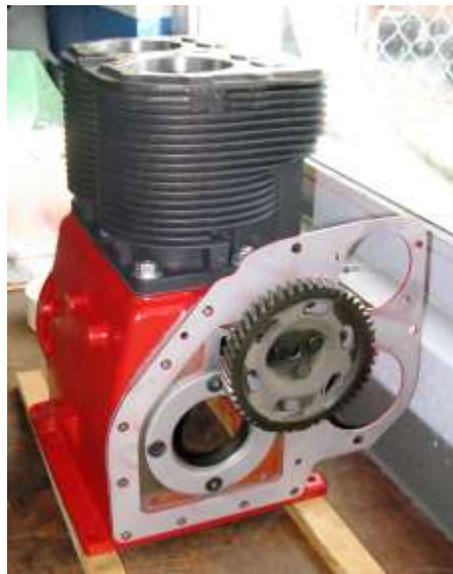
The camshaft was cleaned and inspected and showed no wear on cams or bearings. It was then installed in the crankcase.

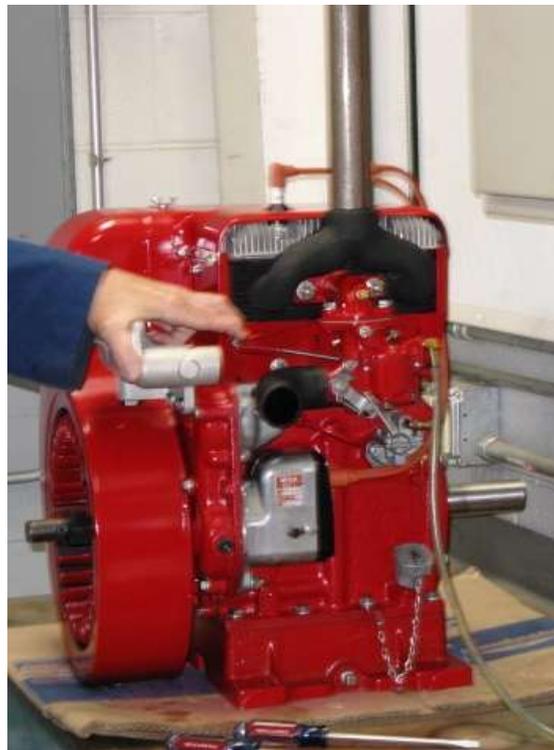
The test run was conducted on the work bench. Throttle was cracked open just a bit and choke full on. Cranked through first compression stroke – nothing. Crank through second compression stroke and a cylinder fires! Choke off – crank through third compression stroke and the engine roars to life with that wonderful, Wisconsin bark! I let it run at a fast idle to warm up and obtain ample lubrication to the new internal components. After several minutes, and a few adjustments to carb idle mixture and speed, it was idling beautifully. A three-foot long, straight exhaust stack was fitted for this run, and several light blips of the throttle were done just to enjoy the authoritative exhaust note. The following picture was taken during this test, with the engine actually running in the photo.

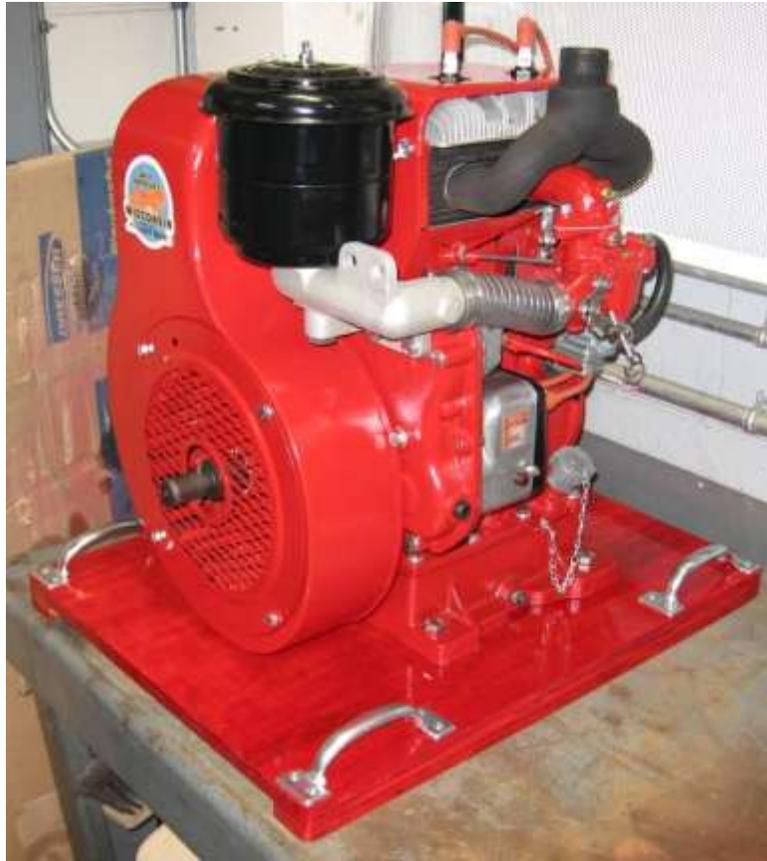
The finished engine, ready for the show circuit, is shown below.
